# Chapter 7

## Lessons Learned

### 7.1 Introduction

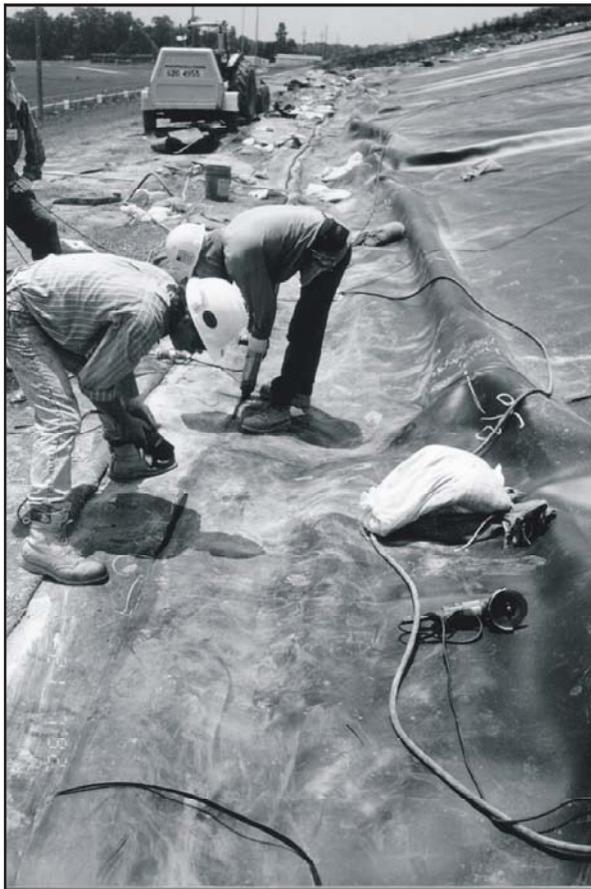
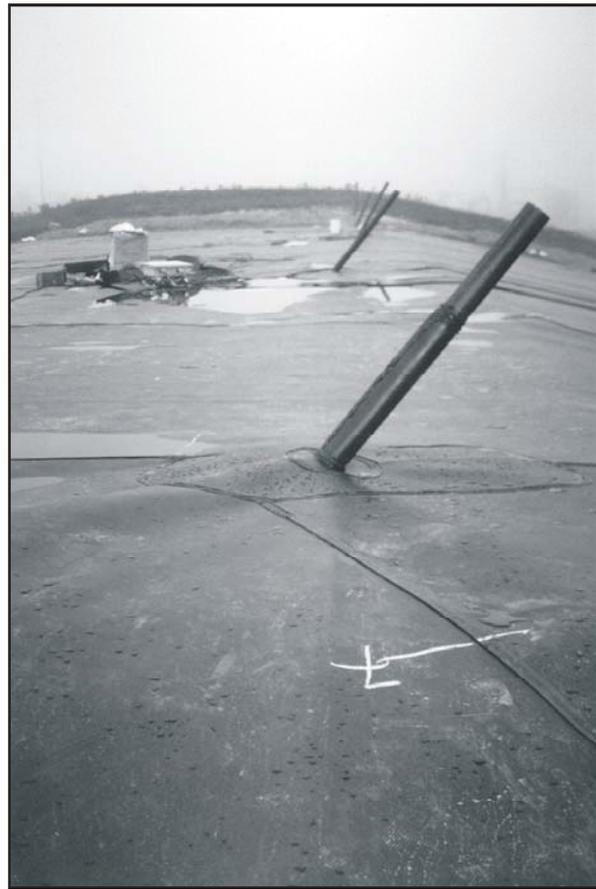
During welding of the tie-in, after a cooling rain, the GM barrier contracted sufficiently to pull on the gas vent pipe boots at the landfill crest. The stress in the GM was sufficient to distort the gas vent pipes from a vertical to an inclined position (Figure 7-6b). Repairs were made to the affected pipe penetrations by the installation of additional compensation wrinkles near the pipe penetrations.

**Figure 7-6. Effect of Temperature Fluctuations During GM Installation: (a) GM Wrinkles at Sideslope Toe; and (b) GM Contraction after a Rain.**

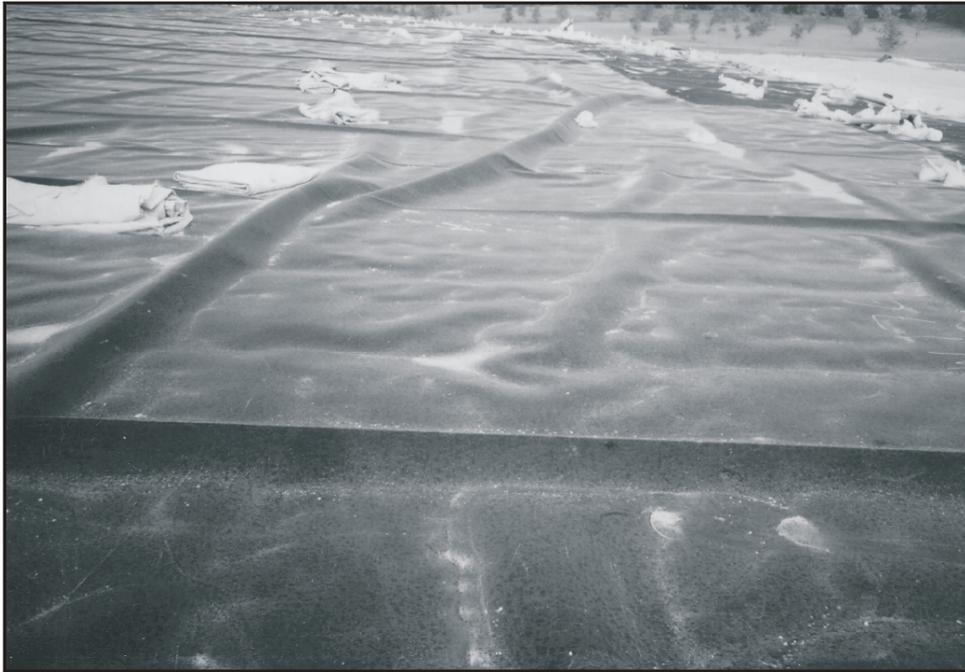
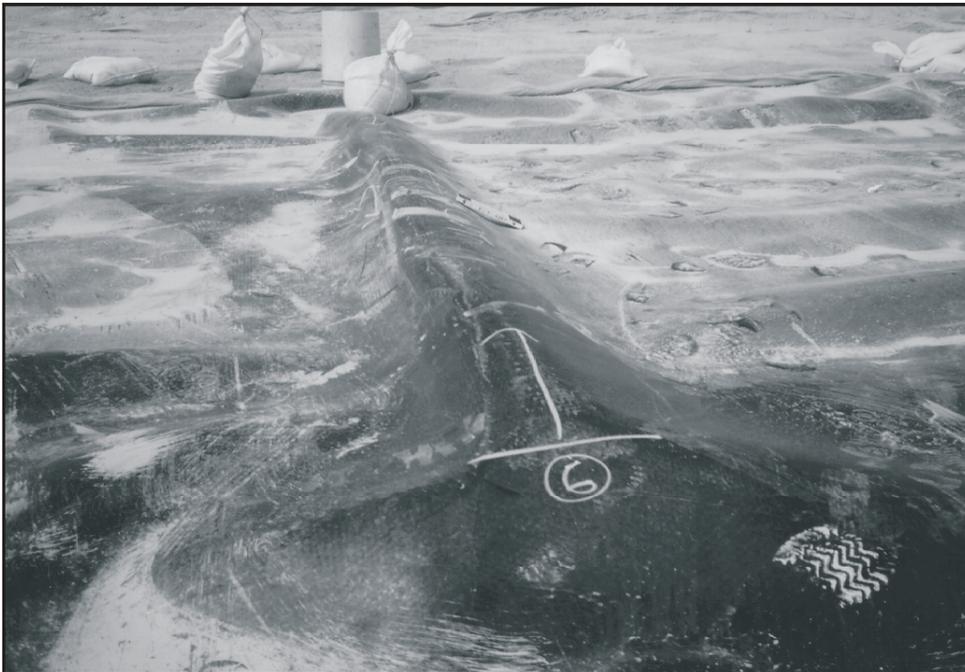
Even though spotters had been used during the initial placement of the cover soil, wrinkles in the GM were found to occur. This case history further highlights the need to control placement of soils over geosynthetics and to minimize wrinkling in GMs. It is important to keep GM wrinkles from folding over since this creates strain concentrations, and hence stress concentrations, in the GM. It is noted that it has been shown analytically that the size of the wrinkles can be reduced by increasing the shear strength between the GM and the underlying material (Giroud, 1994). Therefore, for example, the use of textured rather than smooth GM may reduce the risk that large wrinkles will form.

**Figure 7-7. Wrinkles Developed in an HDPE GM and Folded Over During Placement of Cover Soil.**

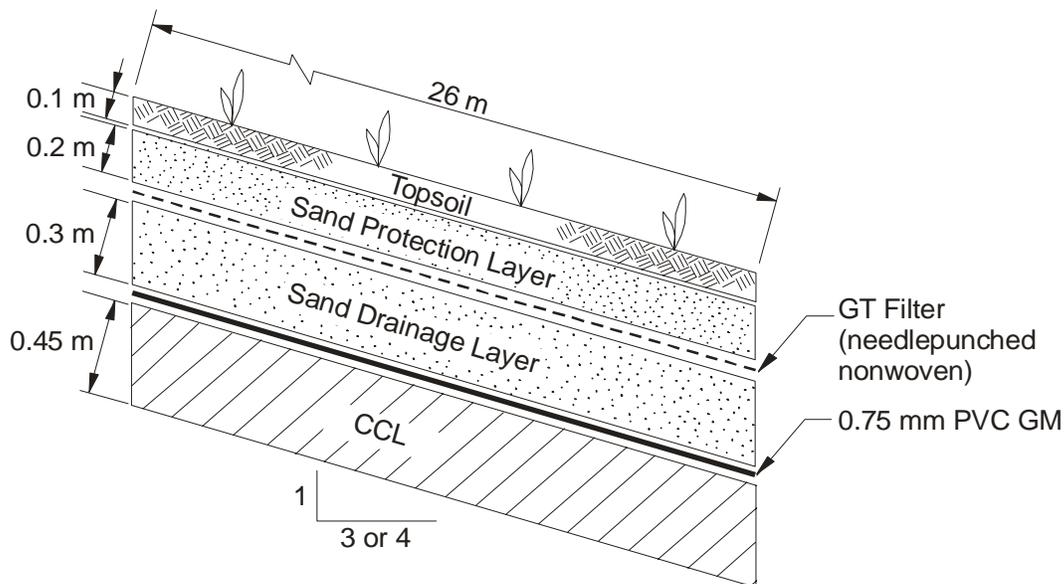
**Figure 7-9. Cover System Cross Section for Northern Ohio Landfill that Underwent a Slope Failure after Thaw.**

A few days after the first spring thaw, the PVC GM component of the cover system slid over the CCL component on a portion of 4H:1V slope. An initial investigation after the failure revealed that water could not exit from the sand drainage layer because the lower end of the drainage

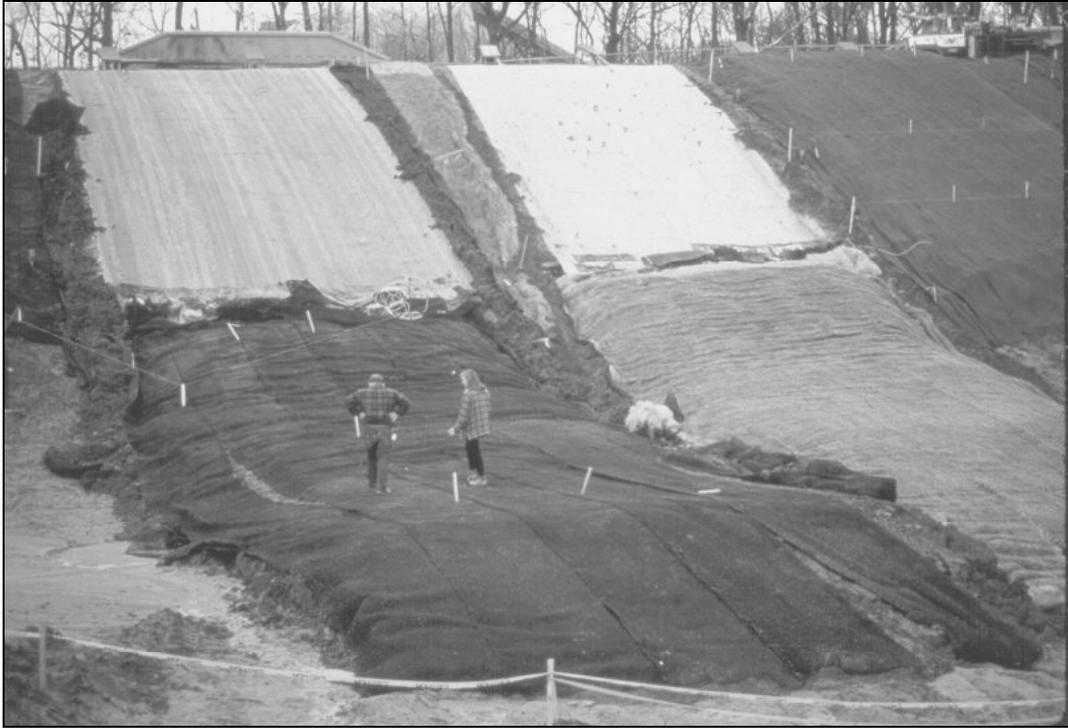
**Figure 7-15. Plots G (Left) and H (Right) Approximately Two Months After Construction and Several Days after the Slide in Plot G.**

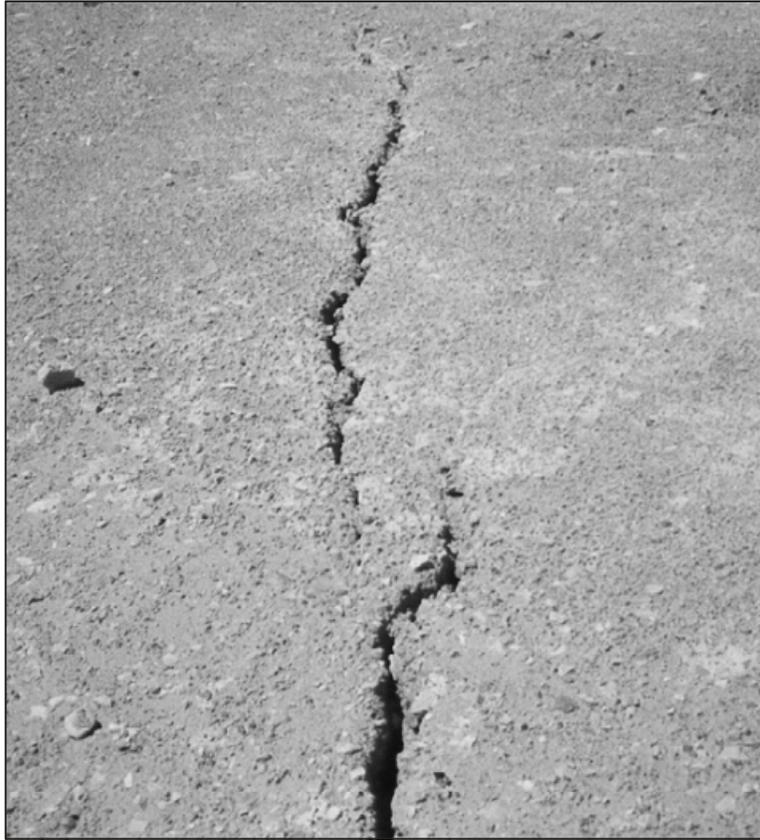
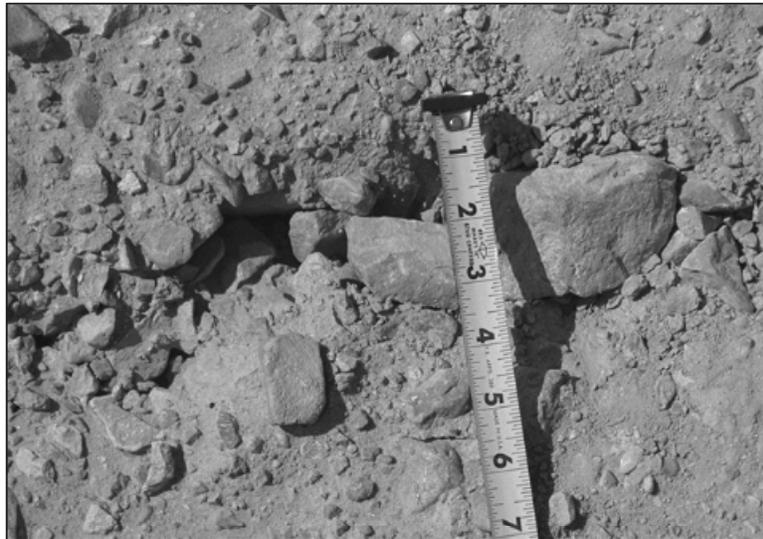
Another example of the impacts of settlements on a cover system is shown in the photographs in Figure 7-16. Surface tension cracks caused by differential settlement of underlying MSW are clearly evident. The cracks occurred in a soil cover system at an arid site in the western U.S.

**Figure 7-16. Surface Tension Cracks in Cover Soils from Differential Settlement of Underlying MSW.**

The soil material used to construct the cover consists of a silty, gravelly sand, intended to be resistant to erosion and desiccation cracking. These cracks were observed to occur throughout the cover system, with most aligned perpendicular to the slope (constant elevation). The cracks were observed to act as drains for surface runoff during infrequent storm events, allowing percolation into the waste mass.

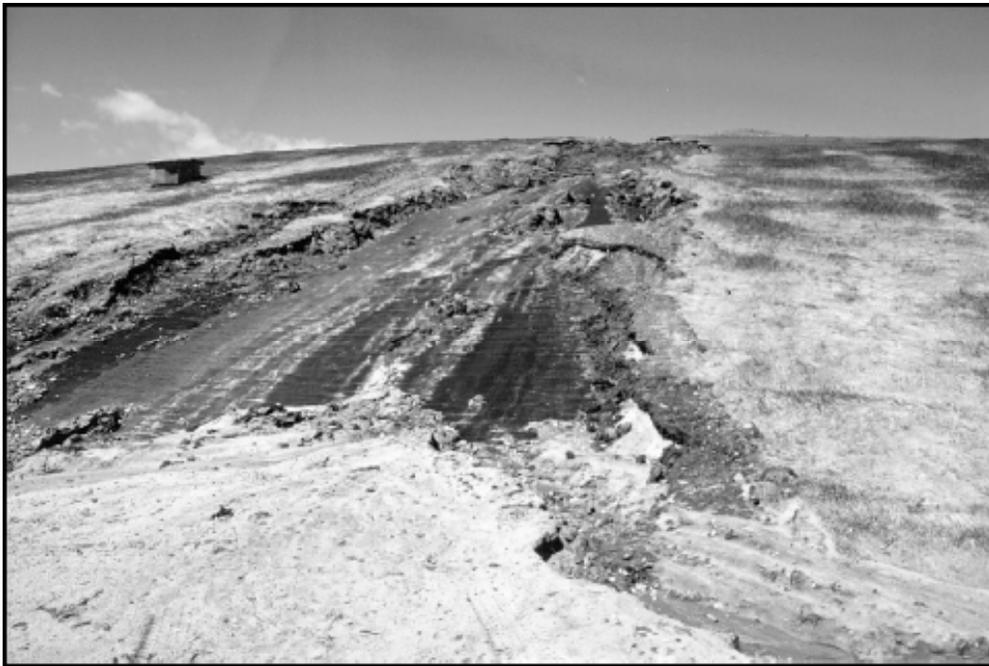
**Figure 7-17. Deep Gullies Through the Topsoil and Sand Drainage Layers Exposed the GM Barrier on 60-m Long, 3H:1V Landfill Sideslopes.**

- Design of the drainage layer at slope transitions (e.g., drain outlets and benches) is critical to the effective functioning of the drainage layer. If not properly designed, flow will back up and generate hydraulic pressure at the slope transition. For flow not to back up in a drainage layer flowing full, flow capacity across the slope transition must not decrease. Chapter 4 of this document provides guidance on the design of internal drainage layers at slope transitions and outlets.

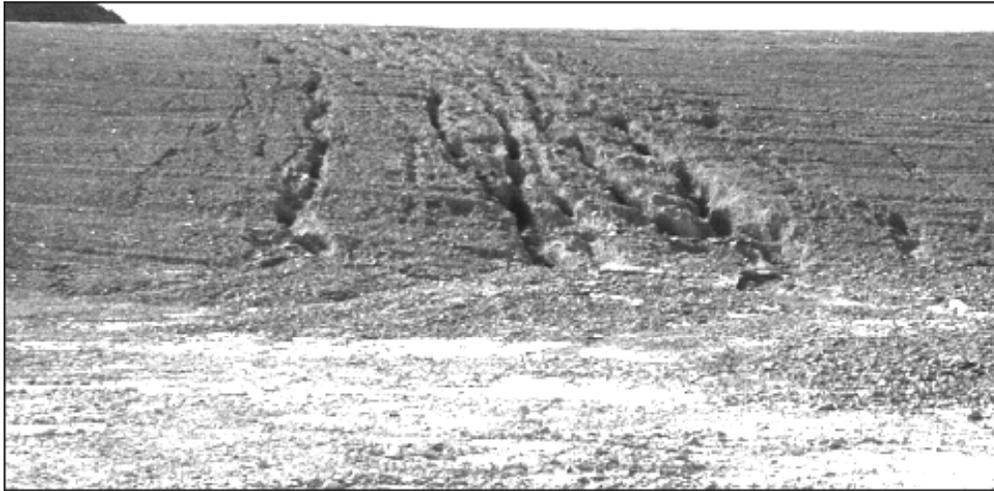
Figure 7-18 presents a photograph (Dwyer 1997) of a RCRA Subtitle D cover system for a closed MSW landfill in an arid area of the western U.S., with no surface-water runoff control system for the portion of the landfill shown in the photograph. Erosion gullies can be clearly seen in the photograph. These gullies were formed by a single intense storm. The gullies were deep enough to cut through the entire cover, exposing waste. The cover system sideslopes are about 3H:1V and the surface layer consists of a silty, gravelly sand.

**Figure 7-18. Gullies on a RCRA Subtitle D Cover System without Surface-Water Runoff Control System and Located in an Arid Setting.**

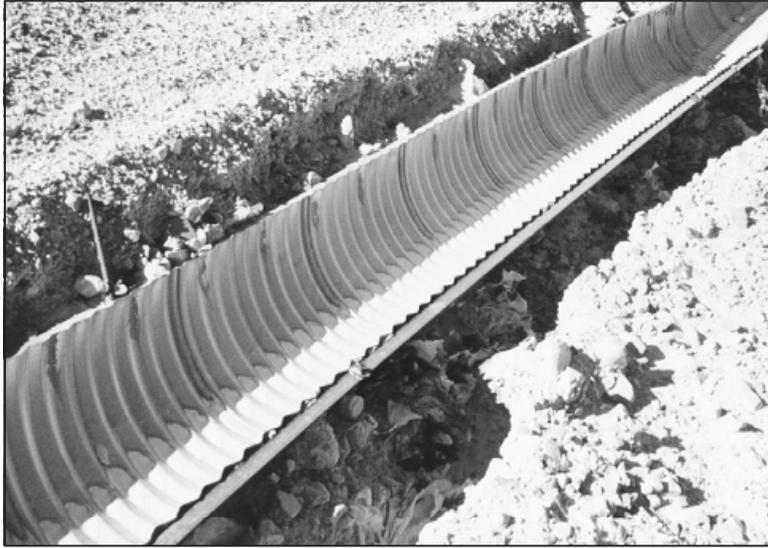
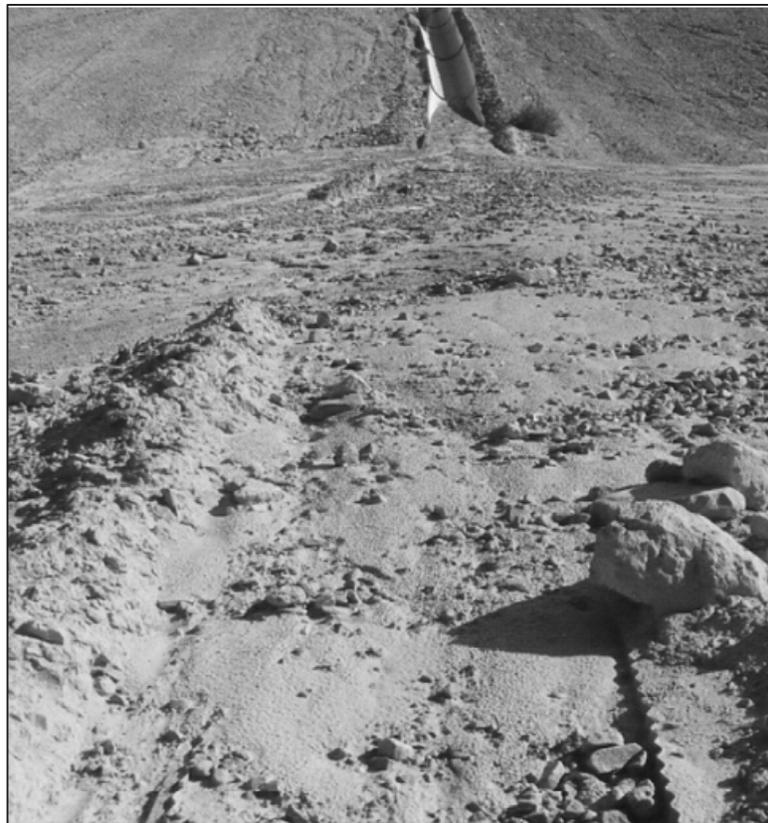
Figure 7-19 presents photographs of a failed surface-water runoff control system for another portion of the closed MSW landfill at an arid climate site described above. The control system consists of corrugated metal pipe-arch culverts installed in the cover system to both intercept downslope surface-water runoff (culverts placed perpendicular to slope) and convey collected runoff to a designated collection area (culverts placed in downslope direction). The design basis for the culverts is not known. The hydraulic capacity of the culverts was not adequate to contain the runoff and overflow occurred during previous storm events. It appears that the sides of the culvert blocked entry of runoff into the culvert, causing surface water to flow parallel to the culvert. This resulted in erosion adjacent to, and beneath, the culvert, exposing waste. Also, the culverts were prone to siltation and infilling. The lessons learned from this case study are that non-vegetated cover soils must be designed to convey surface-water runoff without excessive erosion, runoff interceptors and conveyance structures must be adequately sized, and inlets to the structures must be designed to not impede the inflow and cause erosion around the structure.

**Figure 7-19. Failed Surface-Water Runoff Control System for Another Portion of the Closed MSW Landfill Located at an Arid Climate Site and Shown in Figure 7-18.**

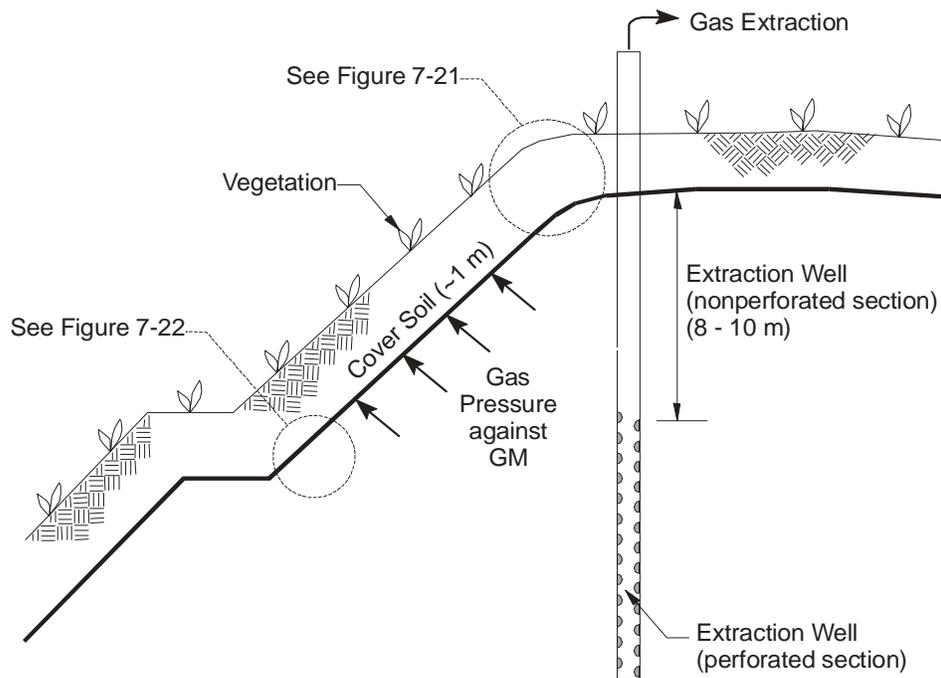
A 40 ha closed MSW landfill was being utilized for gas recovery via deep wells that were placed at approximately 100 m spacings. The cover system included a GM barrier overlain by a combined 1 m thickness of various soil layers (Figure 7-20). The well perforations began 8 to 10 m below the cover system (i.e., the upper portion of the wells were not perforated). As a consequence of the wide well spacing combined with the absence of perforations in the upper part of the well, gas generated in the upper portion of the landfill accumulated beneath the cover system, generating uplift pressures on the underside of the GM. As the gas pressure beneath the GM increased, the normal stress, and, thus, the shear strength, between the underside of the GM and the GT beneath it decreased (Figure 7-20). This resulted in the GM and overlying materials gradually moving downslope. The GM and overlying GC (GT/GN/GT) strained considerably at the top of the slope (Figure 7-21) and folded over at the toe of the slope (Figure 7-22). Tension cracks were also evident at the top of the slope, and bulging of vegetation, cover soil, and geosynthetics was apparent at the toe of the slope. The lesson from this case study is that the spacing of gas extraction wells must be close enough to prevent the buildup of gas pressure on the underside of the cover system. Also, well perforations must not be so deep as to create a “dead zone” with respect to gas collection beneath the cover system. In some cases, a granular or geosynthetic gas transmission layer should be used to provide for more efficient movement of landfill gas to well locations.

**Figure 7-20. Gas Pressures Built Up Beneath Cover System of Closed MSW Landfill Because Upper Portion of Gas Extraction Wells Was Not Perforated.**

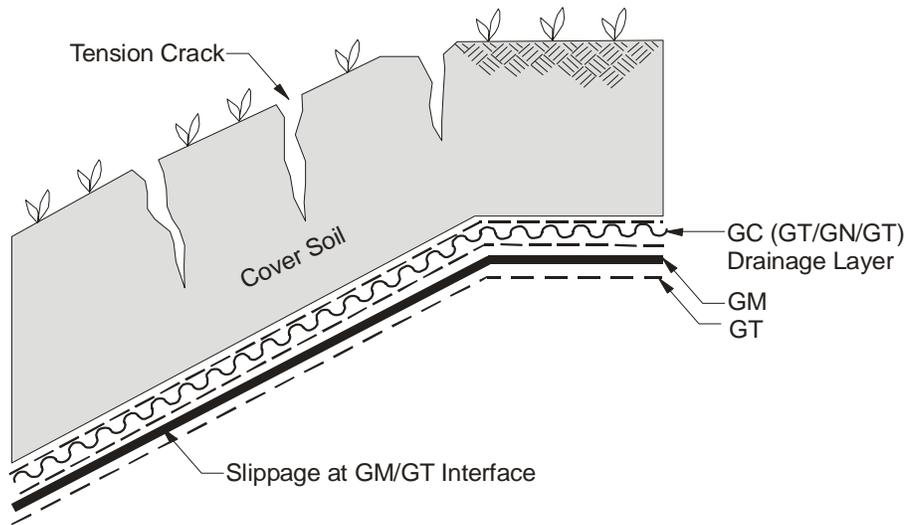
**Figure 7-21. Gas Pressures Beneath Cover System GM Resulted in Slippage at GM/GT Interface with Straining of the GM and GC at the Slope Crest.**

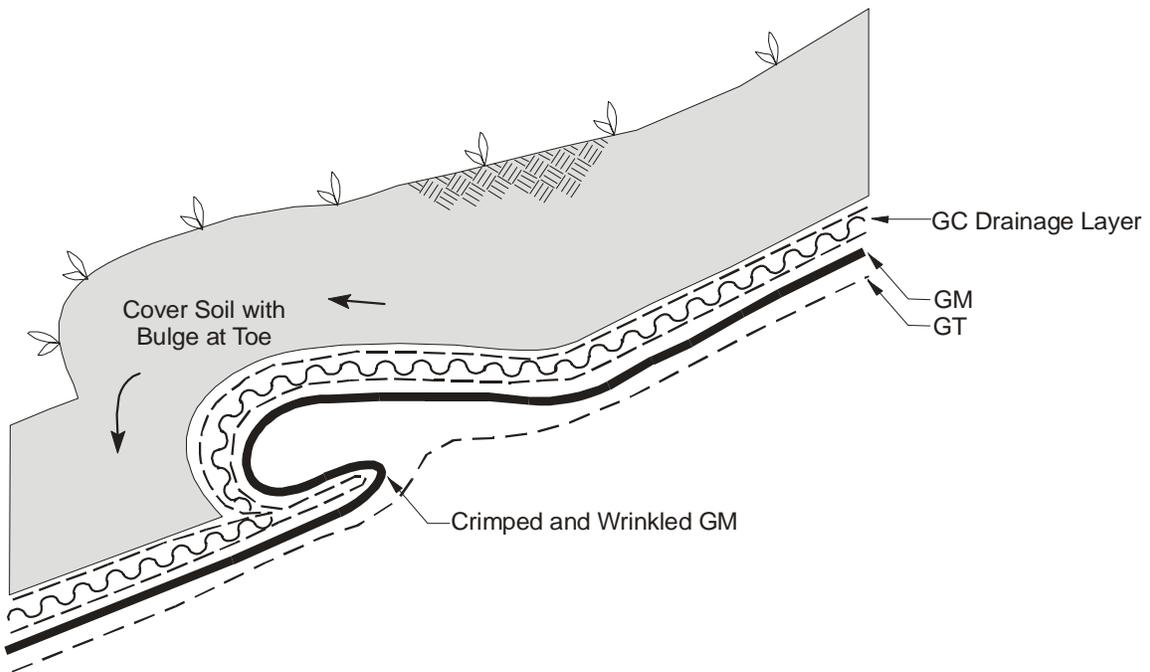
**Figure 7-22. Slippage at GM/GT Interface Also Caused the GM and GC to Fold Over at the Slope Toe.**

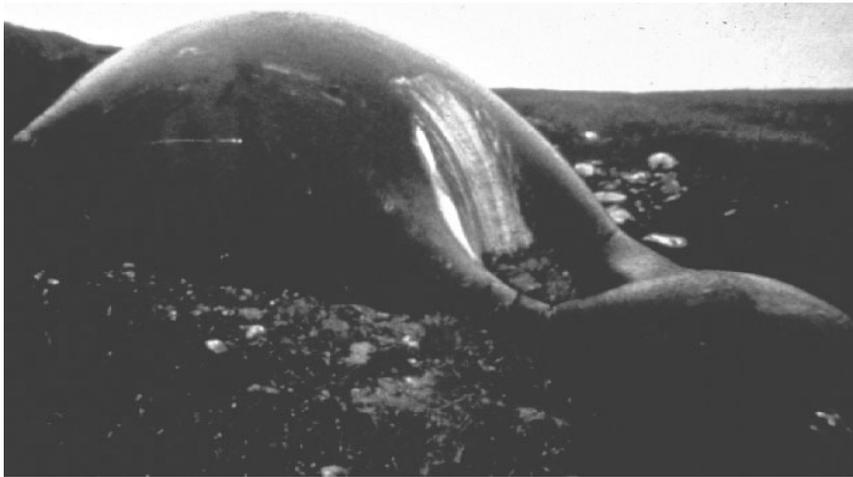
At the extreme, gas uplift pressure can be so great as to cause the GM to push the cover soil aside and expand into a large “whale” as shown in Figure 7-23. The reader should note that this photograph was not taken at the site of the case study described above, but (in other cases) this extreme situation has been observed to occur. Landfill gas, if not collected, will also impact cover systems that do not contain GMs. Vegetation on many landfill cover systems has been killed by landfill gas emissions. Figure 7-24 presents a photograph (Dwyer 1997) illustrating this problem. Even in arid climates with non-vegetated surface layers, the impacts of gas migration can be evident. Figure 7-25 shows surface stains produced by landfill gas throughout the cover of a closed MSW landfill.

**Figure 7-23. GM “Whale” Caused by Gas Pressures Beneath the GM.**

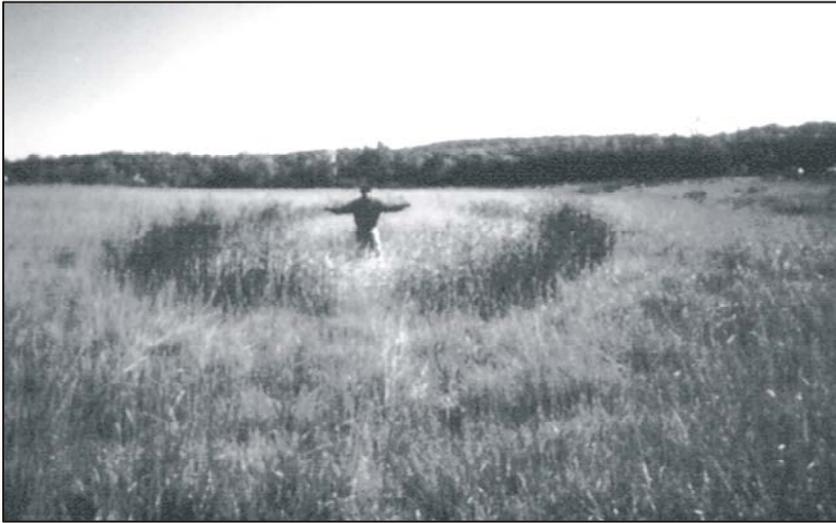
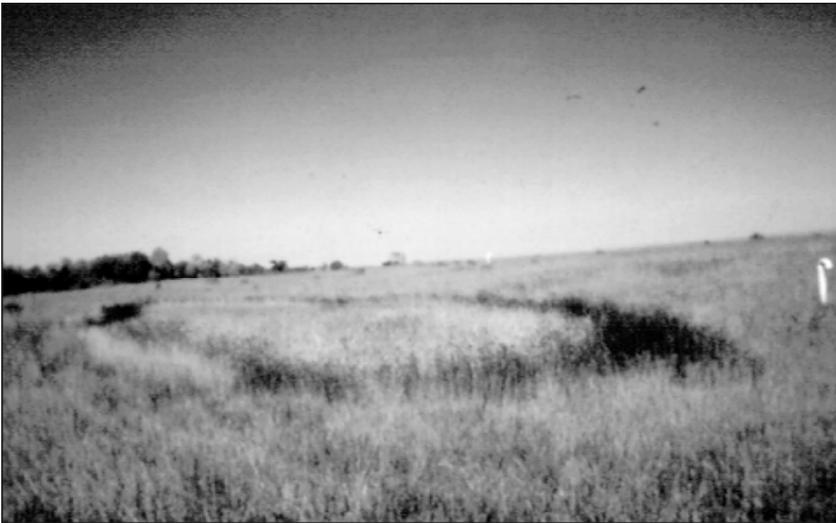
**Figure 7-24. Landfill Cover System Vegetation Killed by Landfill Gas.**

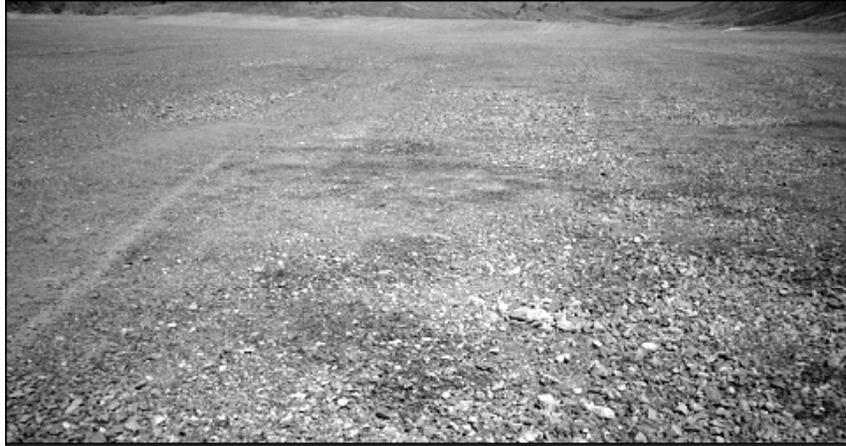
**Figure 7-25. Surface Stains on Landfill Cover System Caused by Landfill Gas.**
