# Chapter 7

## Lessons Learned

### 7.1 Introduction

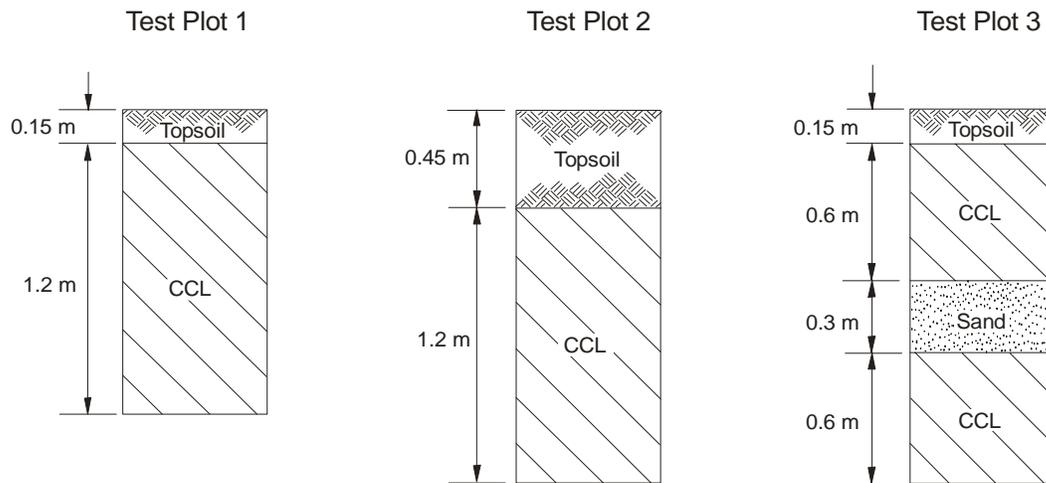
**Figure 7-1. Cross Sections of Cover System Test Plots at a Landfill in Omega Hills, Wisconsin (modified from Montgomery and Parsons, 1989). Test Plot 1 is Representative of the Existing Landfill Cover System.**

- the upper 0.20 to 0.25 m of the CCLs were weathered and blocky;
- cracks 6 to 12 mm wide extended about 0.9 to 1 m into the CCLs in test plots 1 and 2 and through the entire thickness of the uppermost CCL in test plot 3;
- the base of the CCLs in test plots 1 and 2 appeared to be undamaged;
- roots penetrated 0.20 to 0.25 m into the CCLs in a continuous manner, and some roots extended as deep as 0.75 m into cracks in the CCLs; and
- the moisture contents in the upper portion of the CCLs were near the shrinkage limit.

The drought conditions in the second year of the study period apparently caused desiccation of the CCL in test plots 1 and 2, which led to a significantly increased CCL hydraulic conductivity in subsequent years. Although the CCLs in these tests plots may have initially had a hydraulic conductivity of  $1 \times 10^{-9}$  m/s or less, the desiccation damage caused the CCLs to no longer have this low level of hydraulic conductivity.

The principal lessons learned from the Omega Hills study are that in a fairly short period of time (3 years), CCLs overlain by only 0.15 to 0.45 m of topsoil are subject to desiccation, cracking, and increases in hydraulic conductivity. The CCLs were incapable of “surviving” under these conditions with a hydraulic conductivity of  $1 \times 10^{-9}$  m/s or less.

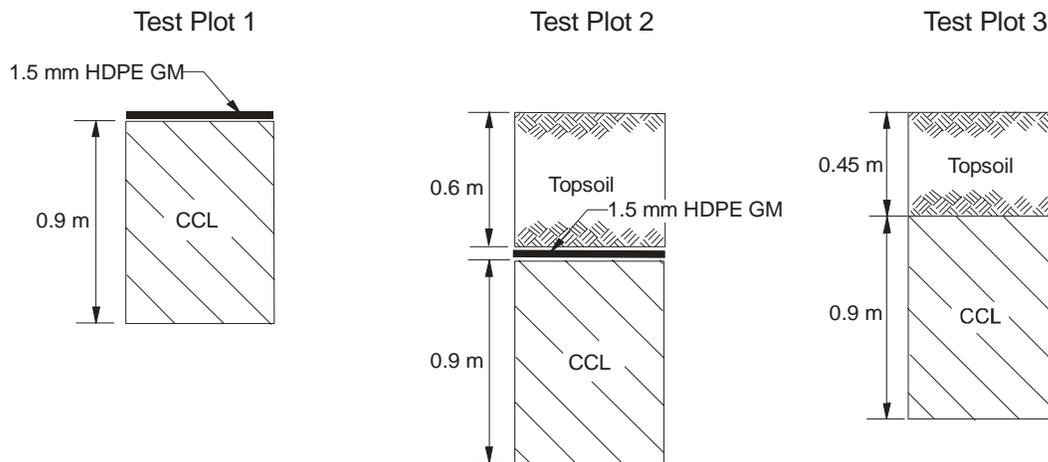
Test plot 1 did not represent a cover system design but, instead, an exposed HDPE GM/CCL composite liner during the construction or operations phase. The clay exhibited some drying and cracking in areas where the GM was not in contact with the CCL. In other areas, where the GM was in contact with the CCL, the moisture content of the CCL at the surface had increased. It appears that the high temperature of the exposed HDPE GM caused heating and drying of the

**Figure 7-2. Cross Sections of Cover System Test Plots at a Landfill in Kettleman City, California (modified from Corser and Cranston, 1991).**

Test plot 3 did not perform well during the summer season. The CCL dried, and cracking was observed at its surface. In contrast, test plot 2 performed well. There was no evidence of drying or cracking of the CCL.

Although the test plots were observed for only six months, significant deterioration of the CCLs was observed in test plots 1 and 3. Only test plot 2, in which the CCL was covered with a GM and 0.6 m of topsoil, performed well. The observations from Kettleman City are consistent with those of Omega Hills and suggest that perhaps the only practical way to protect a CCL from desiccation damage in typical cover system applications is to cover it with a GM overlain by a sufficiently thick layer of soil.

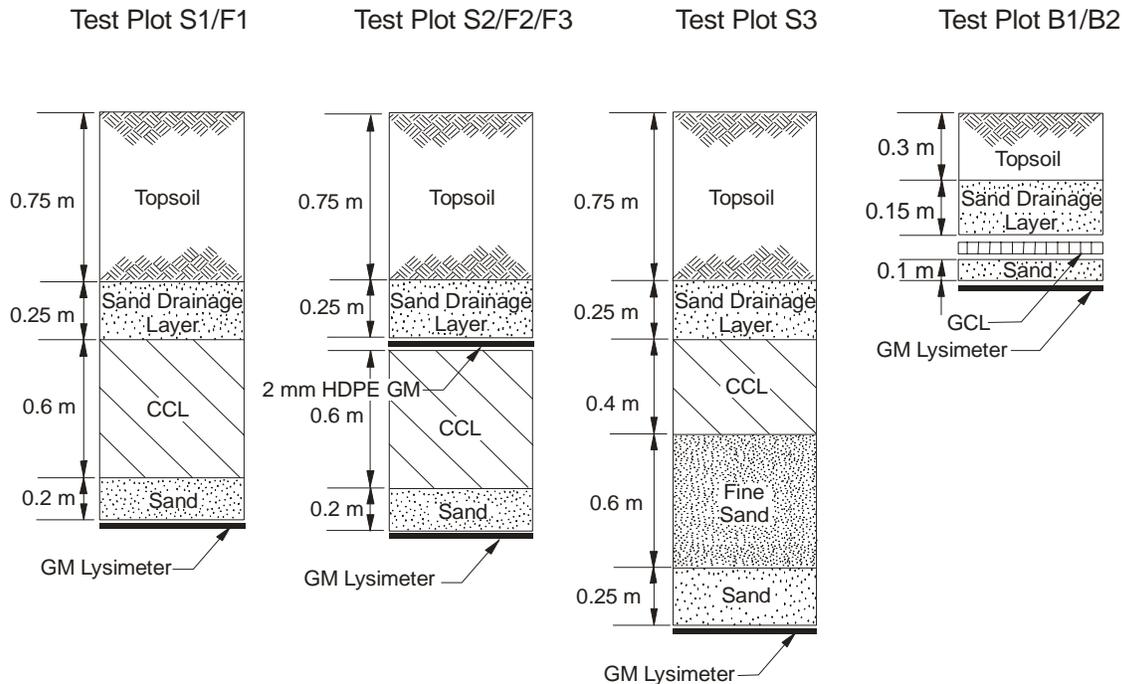
**Figure 7-3. Cross Sections of Cover System Test Plots at a Landfill in Hamburg, Germany (modified from Melchior et al., 1994; Melchior, 1997a).**

As can be observed from inspection of the data in Tables 7-3 and 7-4, test plots F1, S1 and S3, which did not have a GM overlying the CCL, underwent large increases in percolation rate within three to four years after installation. In particular, the summer of 1992 was very dry in Hamburg, and the subsequent fall season was very wet. By 1992, actual percolation rates exceeded 100 mm/year in two of the three CCL test plots. The third CCL test plot exceeded this percolation value by 1993. Excavations made in 1993 confirmed that the CCLs in these test plots were cracked. Barely visible fissures were observed between soil aggregates (around 50 mm in diameter). By 1995, plant roots were observed to have extended more than 1 m into the cover system, reaching the upper parts of the CCLs. In summary, the performance of the test plots containing a CCL without GM protection has been poor. The apparent problem is gradual deterioration of the CCLs caused by desiccation during a particularly dry summer. Detailed results for test plot S1 are presented in Figure 7-4 for illustration purposes.

Percolation rates through test plots S2, F2, and F3, which contain a CCL overlain by a GM, have been very low. Test plots F2 and S3, which incorporate a continuously-welded HDPE GM, had average measured percolation rates of 1.3 mm/year, while test plot F3, which has an overlapped (not welded) GM, exhibited an average measured percolation rate of 3.6 mm/year. Melchior (1997a) indicated that the measured percolation is primarily due to thermally-driven unsaturated flow of pore water in the CCL, not to leakage through the GM.

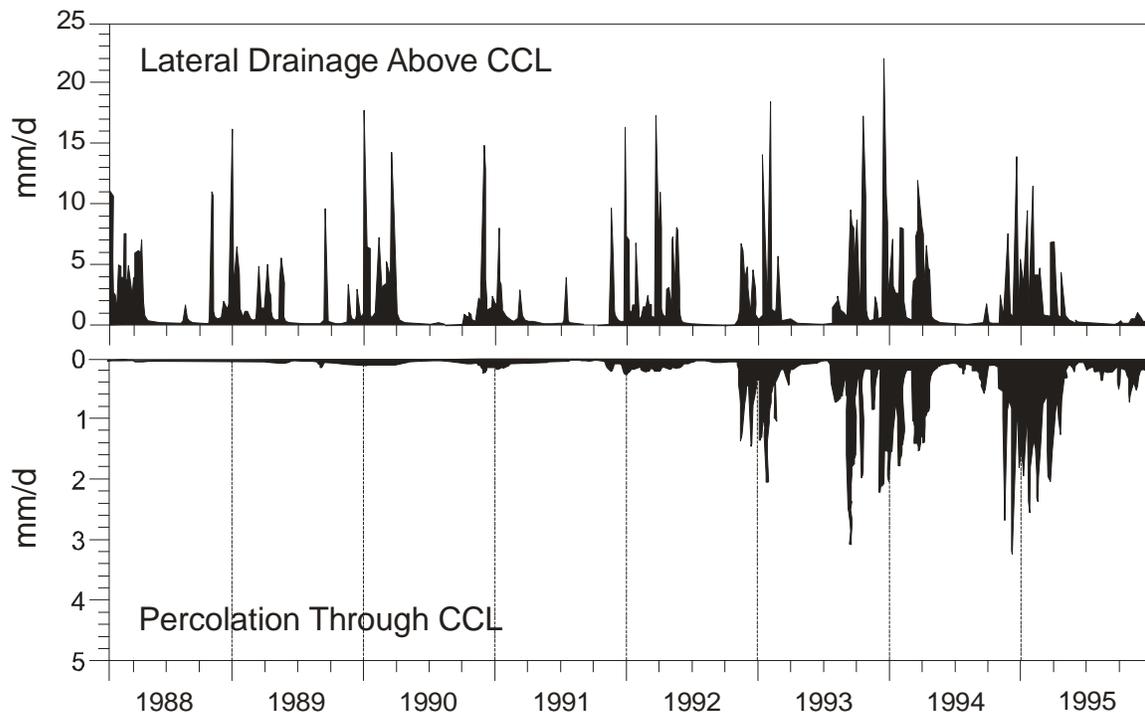
**Figure 7-4. Summary of Field Data for Test Plot S1 with a CCL Barrier at a Landfill In Hamburg, Germany (modified from Melchior, 1997a).**

CCL is to have a chance of maintaining a low hydraulic conductivity for an extended period, the CCL must be protected with both a GM and a sufficiently thick layer of cover soil above the GM. Furthermore, if a GCL is used in lieu of a CCL, the GCL must be chemically-compatible with adjacent soils.

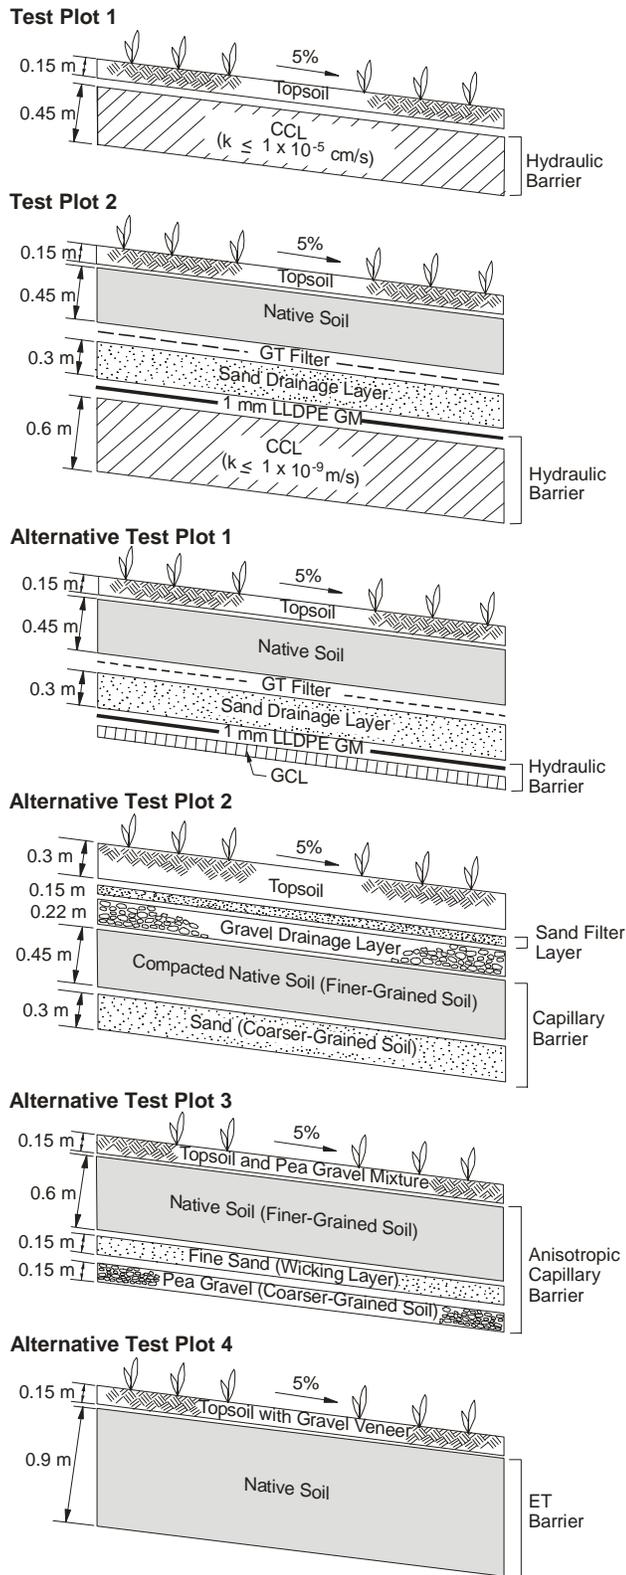
**Figure 7-5. Cross Sections of Cover System Test Plots at Kirtland Air Force Base in Albuquerque, New Mexico (modified from Dwyer, 1997).**

Test plot 1 has a RCRA “Subtitle D” prescriptive minimum criteria cover system (hydraulic barrier type). The hydraulic barrier for this system consists of a 0.45-m thick CCL ( $k \leq 1 \times 10^{-7}$  m/s). The measured annual percolation through this cover system during the first three years of monitoring averaged 4.82 mm. Dwyer (1998) reported *“As expected, the subtitle D soil cover performed poorly.... Desiccation cracking, freeze/thaw cycles, root penetration, and earthworm and insect activity have acted to increase the permeability.”*

Test plot 2 has a RCRA “Subtitle C” equivalent minimum technology guidance cover system (hydraulic barrier type). The hydraulic barrier consists of a 0.6-m thick CCL ( $k \leq 1 \times 10^{-9}$  m/s) overlain by a 1-mm thick LLDPE GM. Importantly, the GM had eight 1 cm<sup>2</sup> holes cut into it to simulate installation-induced defects. Reported average annual percolation is 0.13 mm. Dwyer (1998) reported: *“The other baseline cover - the subtitle C compacted clay cover - had little percolation for most of the year. However, in the past few months percolation has been evident, and the percolation rate is expected to slightly increase with time. One problem with this system is that the geomembrane hampers the ability of the barrier layer to dry by ET; consequently, as additional moisture infiltrates the barrier layer it eventually creates percolation.”* With respect to this cover system, two additional comments are provided: (i) the frequency and size of holes in the GM component of the cover system are significantly larger than would normally be anticipated in a good GM installation; and (ii) evaluation by the researchers involved in the project indicate that percolation through the CCL may be primarily due to concentrated flow through desiccation cracks that developed during construction.

Alternative test plot 1 is identical to test plot 2 except that a GCL is used in lieu of a CCL. Reported average annual percolation is 1.81 mm. Dwyer reported (1998): *“The GCL cover is not performing as well as expected. There are eight 1 cm<sup>2</sup> defects in the geomembrane. It is hypothesized that moisture moved through the geomembrane via defects or diffusion and penetrated the GCL seams prior to the seams’ full hydration and sealing. The GCL could also have been damaged during construction, despite very tight quality control, or through root intrusion.”* Dwyer (2001) gave two additional hypotheses for the apparent increase in GCL permeability: (i) *“the bentonite within the geosynthetic clay liner has desiccated and does not fully repair itself after rewetting”*; and (ii) *“the soils in the Southwest or dry environments are susceptible to ion exchange problems that increase the permeability of the liner”*.

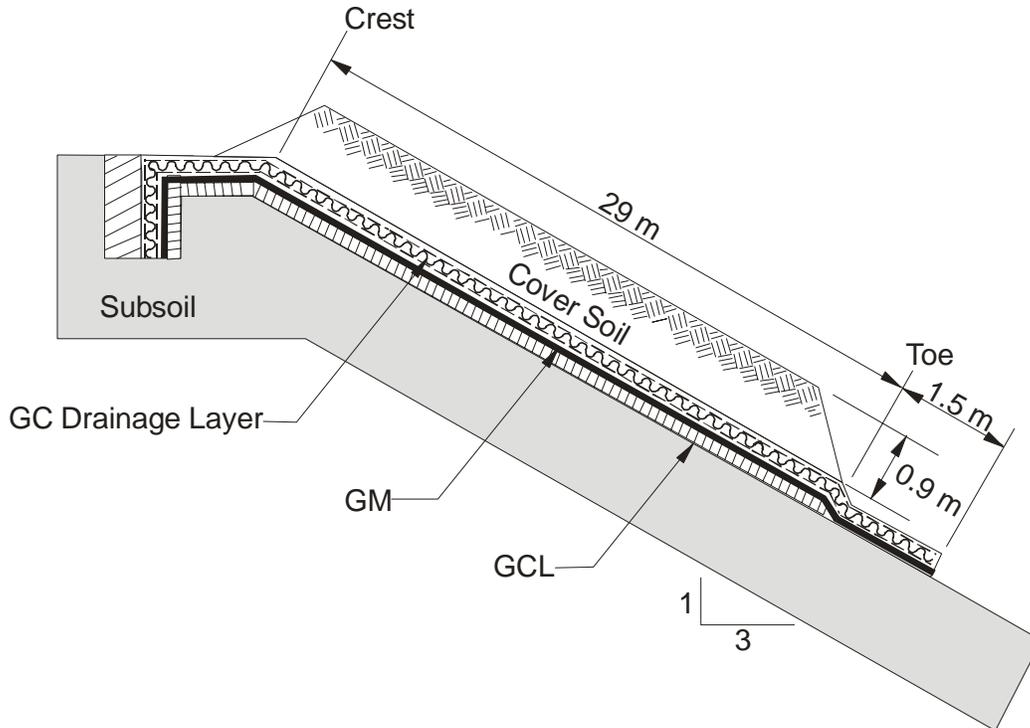
**Figure 7-10. Typical Cross Section for 3H:1V Cover System Test Plot in Cincinnati, Ohio (modified from Carson et al., 1998).**
